Upgrading/ Improvement of Roadside Slope/
Retaining Walls on Hong Kong Island (2005-
2008 Programme) – Investigation, Design and
Construction

Heritage Impact Assessment Report for Feature No. 11SW-B/R93 (Sub- division 1), Duddell Street

Report Ref: M45/200

Final | June 2013

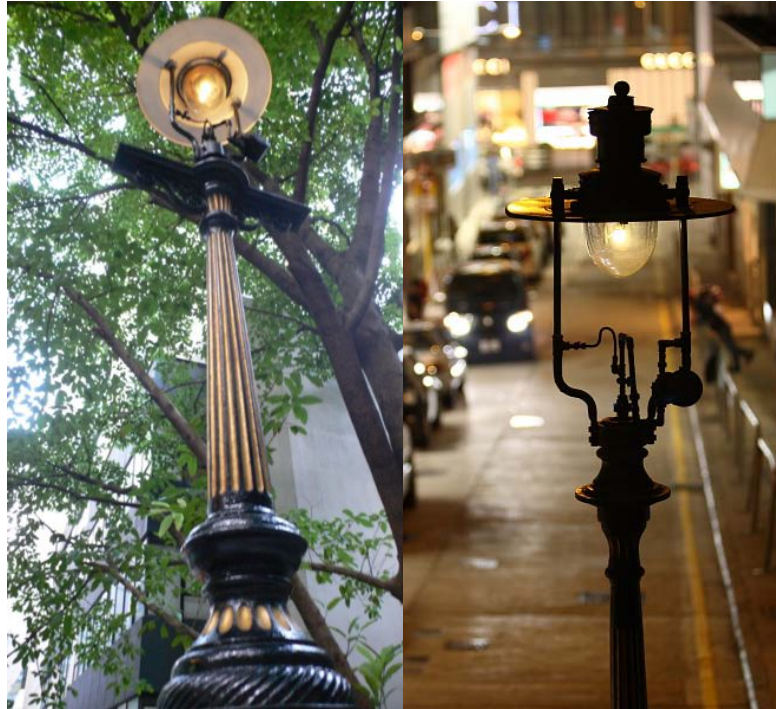
Photo 2.2 – The existing gas lamps surmounting at the crest and toe of the stone steps

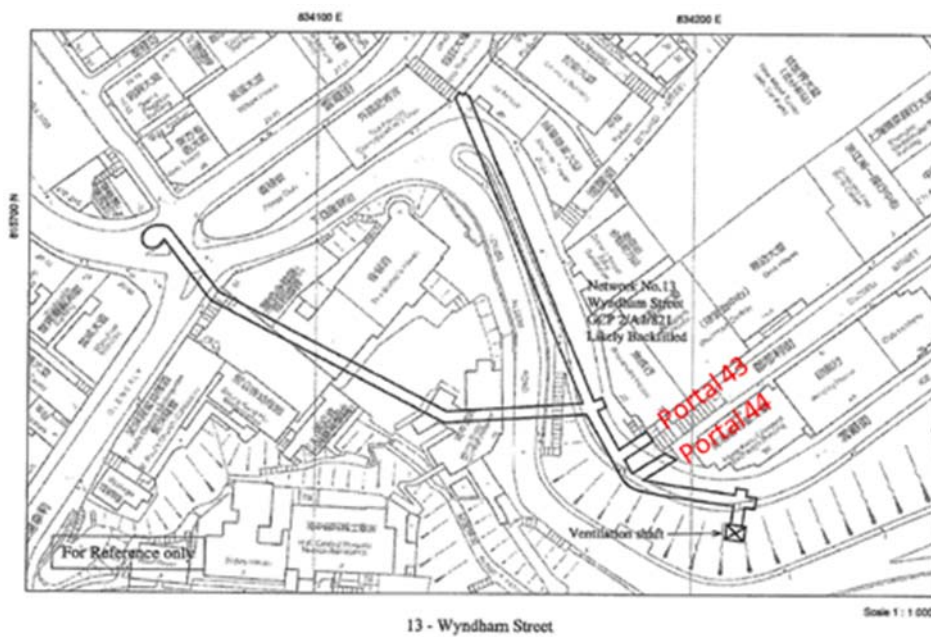
Figure 2.1 – Wyndham Street Tunnel Network

Portal 43 is located at the northern side of the Site while Portal 44 is located at the southern side. Referring to the report during the inspection by Mott, Hay & Anderson Far East in 1982, the tunnel lining for the sections connecting Portals 43 and 44 are in fair and good condition respectively. In both tunnels, the granite masonry sidewalls are in good condition.

However, the report recommended that because of the poor condition of the Wyndham Street tunnel network and the threat it poses to the overlying structures, the network shall be backfilled. It is also recommended that the backfilling to the tunnels shall make provision to maintain the drainage aspects of the network.

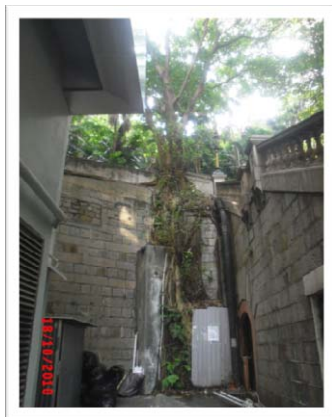
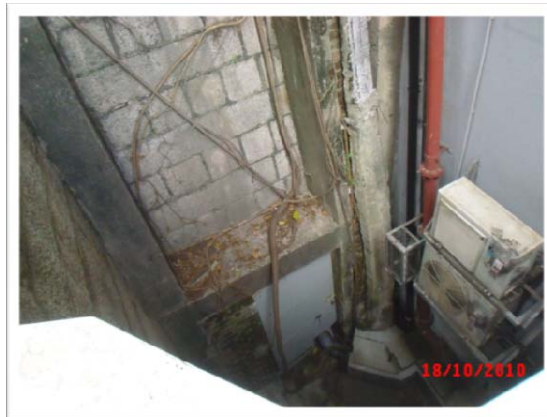
Proposed U/I works:	Installation of soil nails of approximately 16m long at 1m c/c horizontal and vertical grid pattern and construction of a 250mm thick skin wall with stone facing in front of the existing feature.
Affected Elements:	(i) Retaining wall No. 11SW-B/R93 adjacent to the declared monument; (ii) Sidewalls of the declared monuments
Levels of significance:	<u>Acceptable impact with mitigation measures</u>
Photos:	Retaining wall No. 11SW-B/R93, Portals 43, 44 and Part of the Duddell Street Steps are shown below in Photos 3.1 and 3.2

Photos 4.1 and 4.2 – Existing retaining wall above Portals 43 and 44

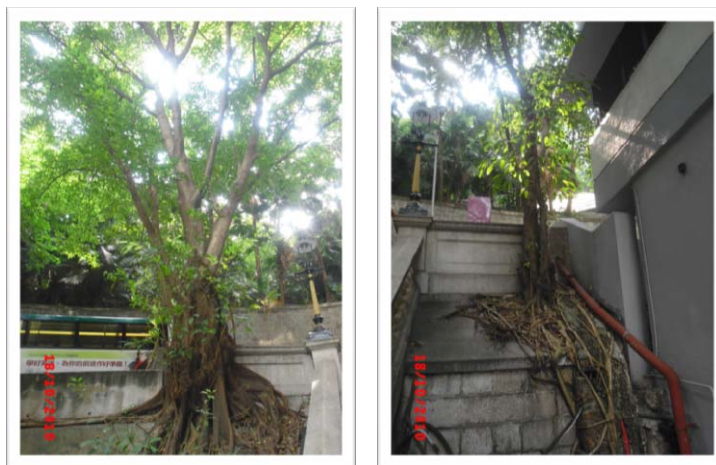
Photos 4.3 and 4.4 – Existing wall trees located above Portals 43 and 44.

The existing wall trees located above Portal 43 and 44 will be closely monitored prior to and during the construction works by professional landscape architect. Tree protection such as covering the tree stems and roots by hessian bags will be carried out. In principal, if the trees conditions were good or fair, no tree felling or tree transplant will be carried out. Similar design was discussed with LCSD/AMO in 2005 and adopted for Feature No. 11SW-C/R307 at Bethanie, Pokfulam. Sample photos are attached in Appendix D for reference.

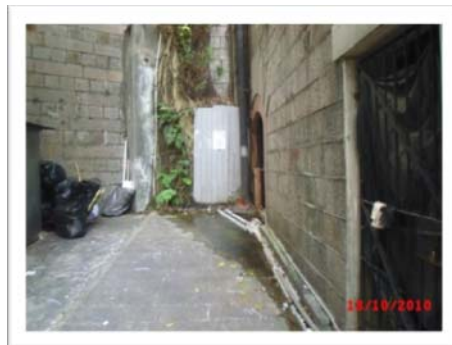
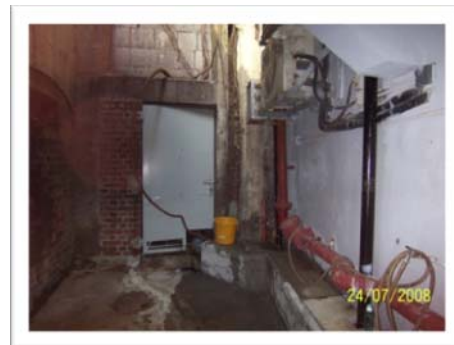
Photos 4.5 and 4.6 – Appearance of Existing Portals 43 and 44

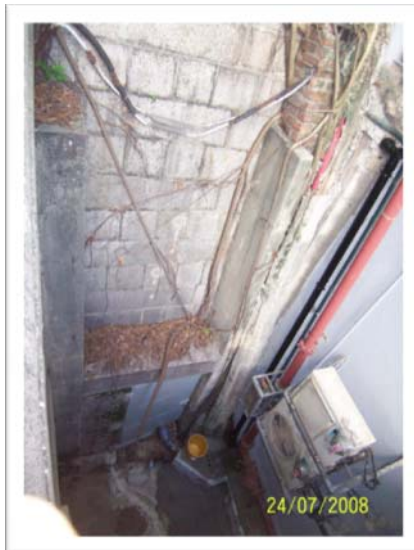
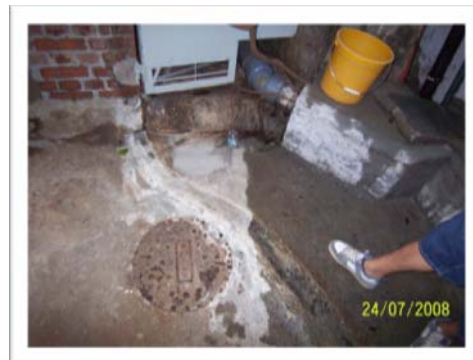
Photos 4.7 and 4.8 – Existing utilities and drainage channels are located on the wall surface and wall toe of Portal 43.

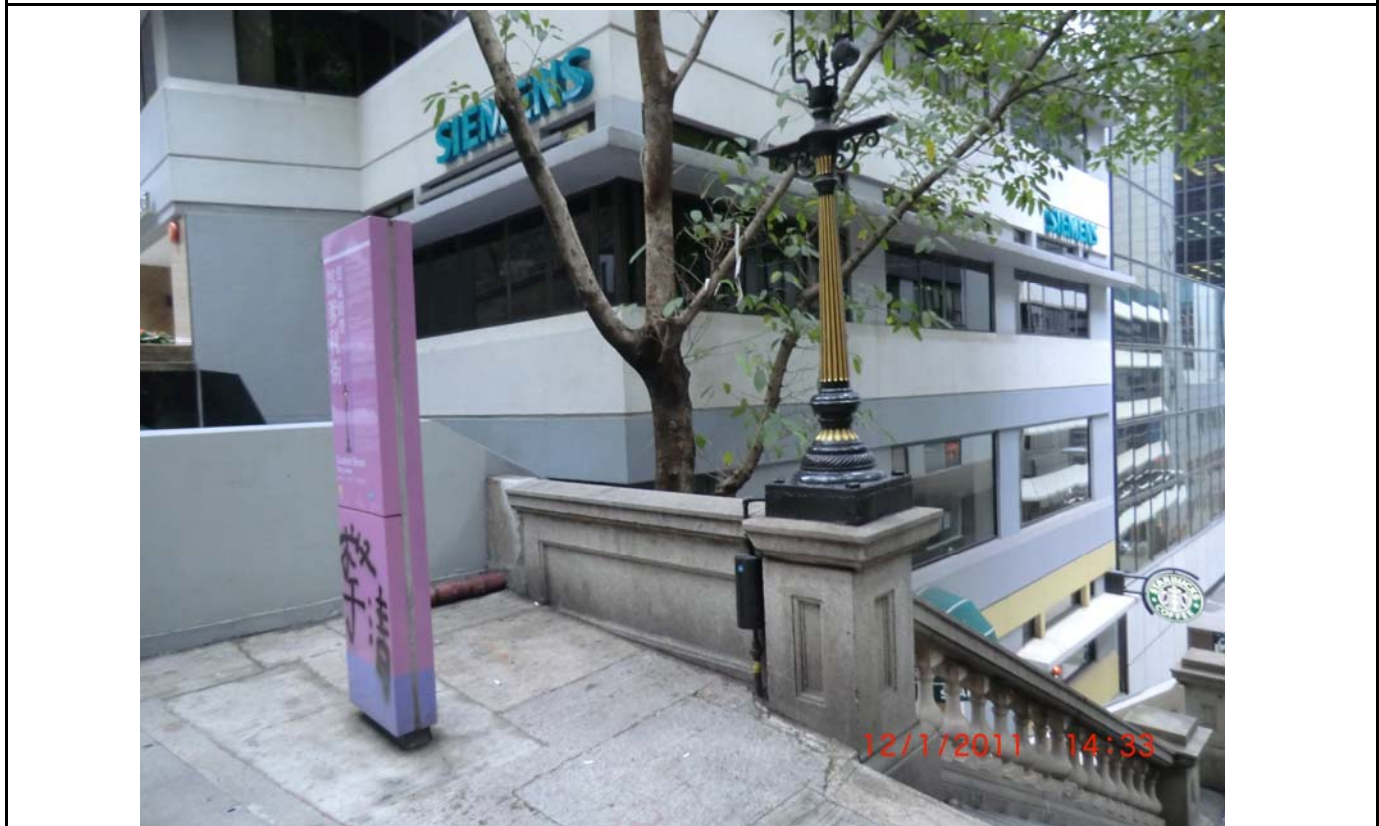
Subject	Feature No. 11SW-B/R93 (Plate 2)	Date photograph taken	12-Jan-11
----------------	----------------------------------	------------------------------	-----------

At the north-western side of the Feature, the parapet wall is connected to an existing concrete wall by cement mortar at the north, a box newel that supports the gas lamp at the south, the pavement of Ice House Street at the west and Feature No. 11SW-B/R93 at the east (please refers to Plate 2 in Appendix B). An existing wall tree is growing above the Feature adjacent to the parapet wall. No tree roots are observed causing damage to the parapet wall at this moment.

Description	View showing the parapet wall at the North-western side of the Feature
--------------------	--

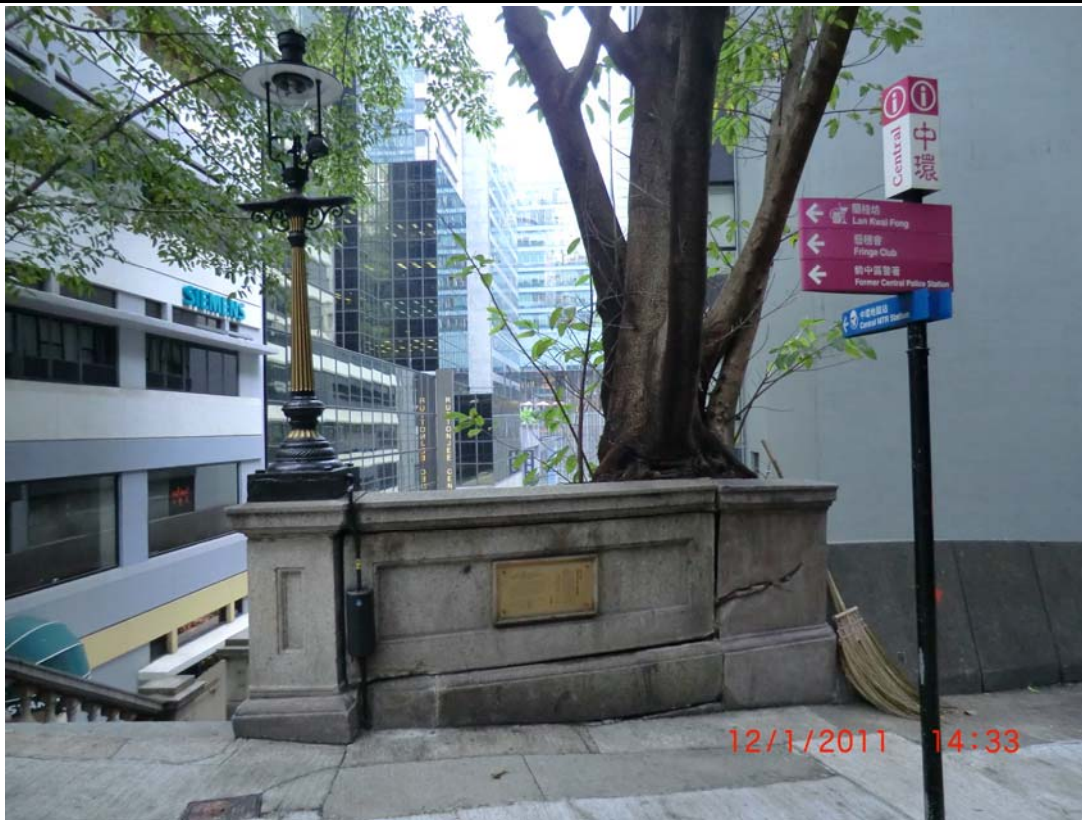
Subject Feature No. 11SW-B/R93 (Plate 3) **Date photograph taken** 12-Jan-11

At the south-western side of the Feature, the parapet wall is connected by cement mortar to an existing concrete wall covered by mosaic tiles at the south, a box newel that supports the gas lamp at the north, the pavement of Ice House Street at the west and Feature No. 11SW-B/R93 at the east (please refers to Plate 3 in Appendix B). Significant gaps of approximately 40mm between the parapet wall to the wall base and to the

Description View showing the parapet wall at the South-eastern side of the Feature

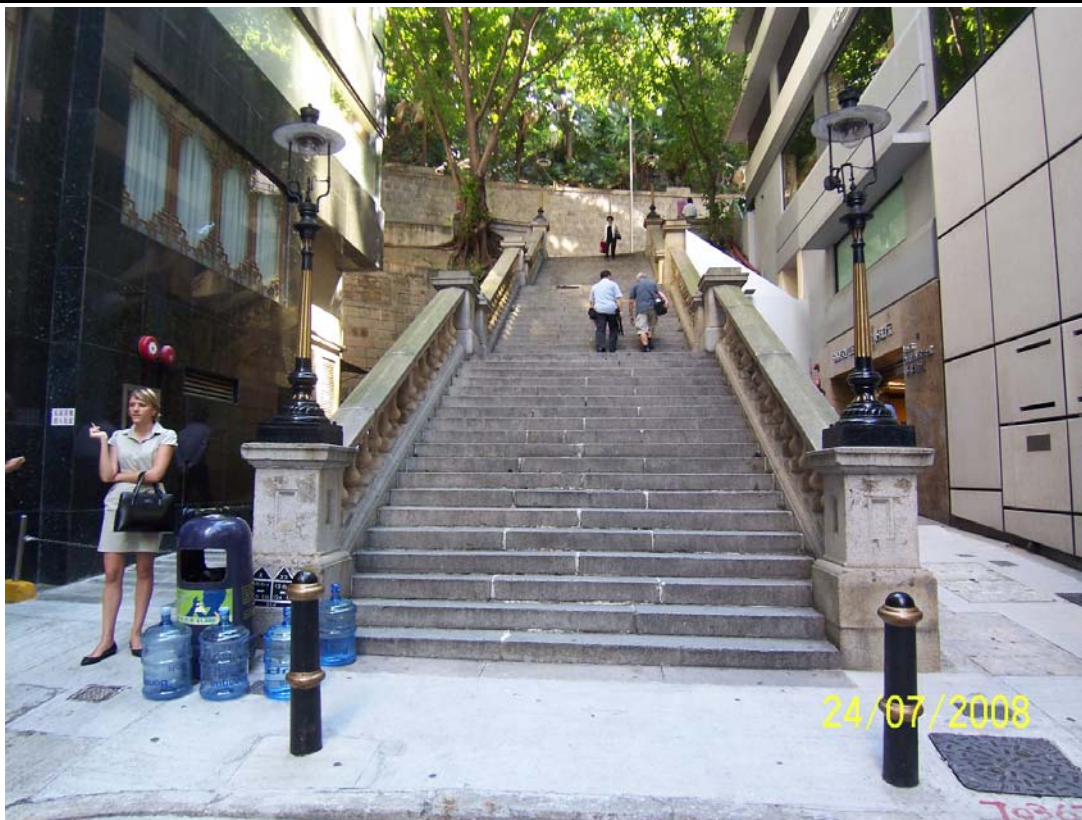
Subject Feature No. 11SW-B/R93 (Plate 4) **Date photograph taken** 24-Jul-08

The granite stone staircase is considered to be part of the declared monuments and is located between Ice House Street and Duddell Street. It is situated in the middle of Feature No. 11SW-B/R93. The staircase is separated into three sections by two landings, the upper, the middle and the bottom sections. In the upper section, 19 treads with a total inclined length of 6.20m are measured during the site inspection. For the middle and bottom sections, total of 18 and 19 treads with inclined length of 5.85m and 6.20m were measured during the site inspection respectively. Total of 56 treads forming this declared monument (please refer to Plate 4 in Appendix B).

Description General view of the feature toe at Duddell Street

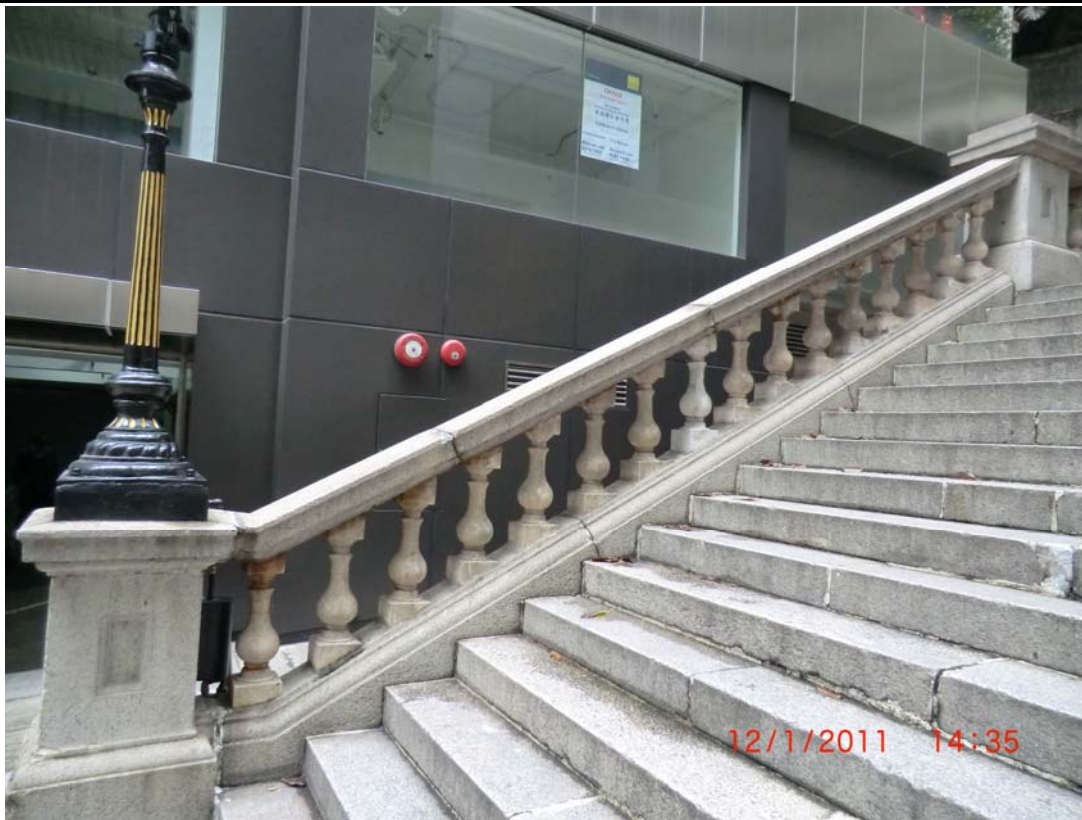
Subject Feature No. 11SW-B/R93 (Plate 5) **Date photograph taken** 12-Jan-11

All the granite stone handrailings are supported by balusters of approximately 0.6m tall in lanterns shape. For the southern portion, 16, 17 and 16 balusters are found at the upper, middle and bottom sections of handrailings respectively. Total of 4 balusters are found between the box newels at the landing sections. The entire handrailings are connected by box newels. For the northern portion, 15, 15 and 16 balusters are found at the upper, middle and bottom sections of handrailings respectively. Total of 2 balusters are found between the box newels at the lower landing section. However, the northern portion of granite stone handrailings is discontinued at the upper landing for 1.50m. A small section of staircase is constructed at this opening and is connected to the adjacent building (Baskerville House) (please refers to Plate 5 in Appendix B).

Description View showing the granite stone handrailings

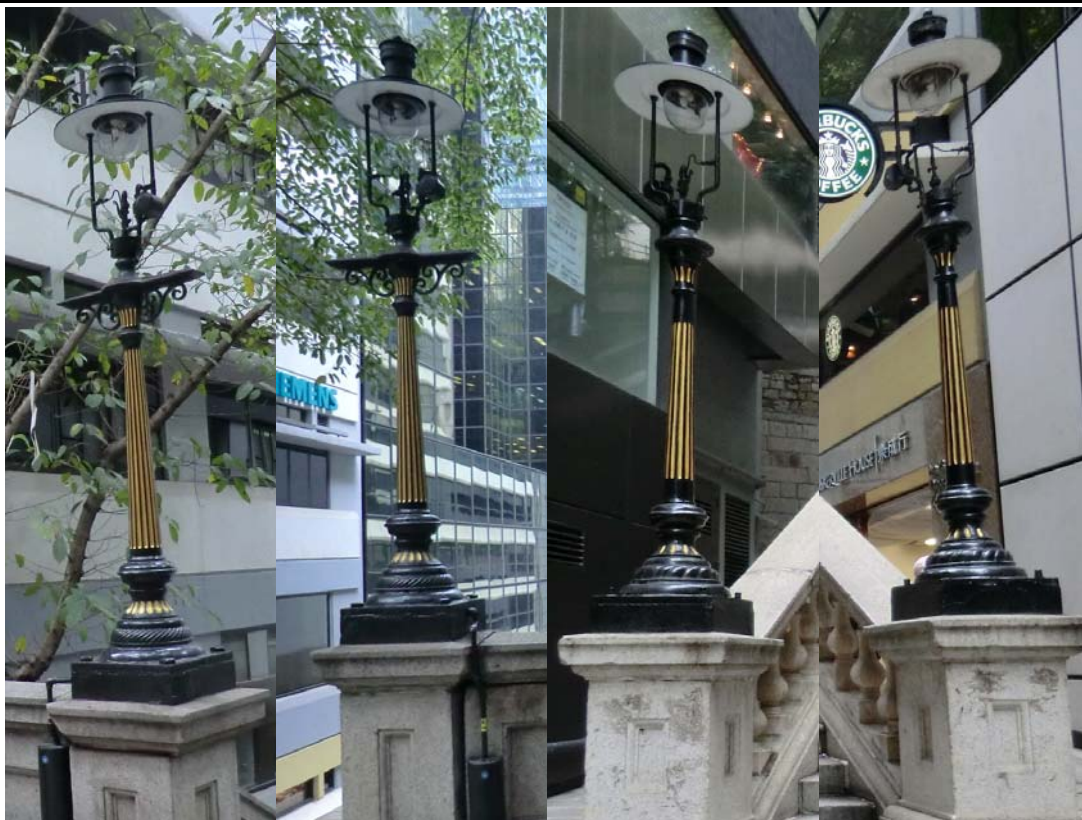
Subject Feature No. 11SW-B/R93 (Plate 6) **Date photograph taken** 12-Jan-11

The four gas lamps located above the box newels are considered to be part of the declared monuments – two located at Ice House Street and two located at Duddell Street. Each gas lamp post is described as two-light Rochester models with a height of approximately 2.50m, connected to a gas pipe maintained by The Hong Kong and China Gas Company. Except the strips on the lamp post in gold colour and the interior of the lampshade in white colour, the lamp is mainly in black colour. During the inspection, the gas lamps are functioning and in good condition (please refers to Plate 6 in Appendix B).

Description View showing the conditions of the 4 gas lamps at Duddell Street

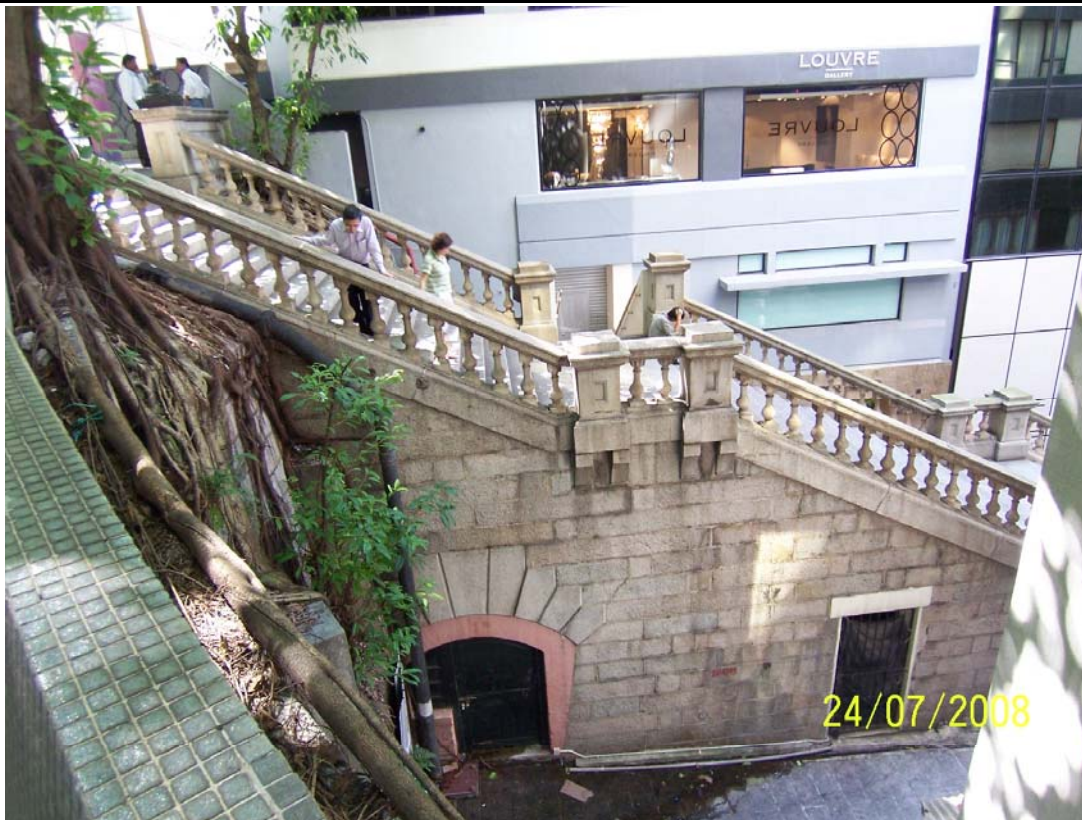
Subject Feature No. 11SW-B/R93 (Plate 7) **Date photograph taken** 24-Jul-08

The granite masonry blocks installed on the sidewalls of the staircase are considered to be part of the declared monuments. It is considered that the walls are mainly constructed by granite blocks of size 0.30m x 1.70m x 0.30m in a staggered pattern. The existing physical conditions of the granite masonry blocks are good without obvious cracks (please refer to Plates 7 & 8 in Appendix B).

Description General view showing part of the sidewalls of the declared monument

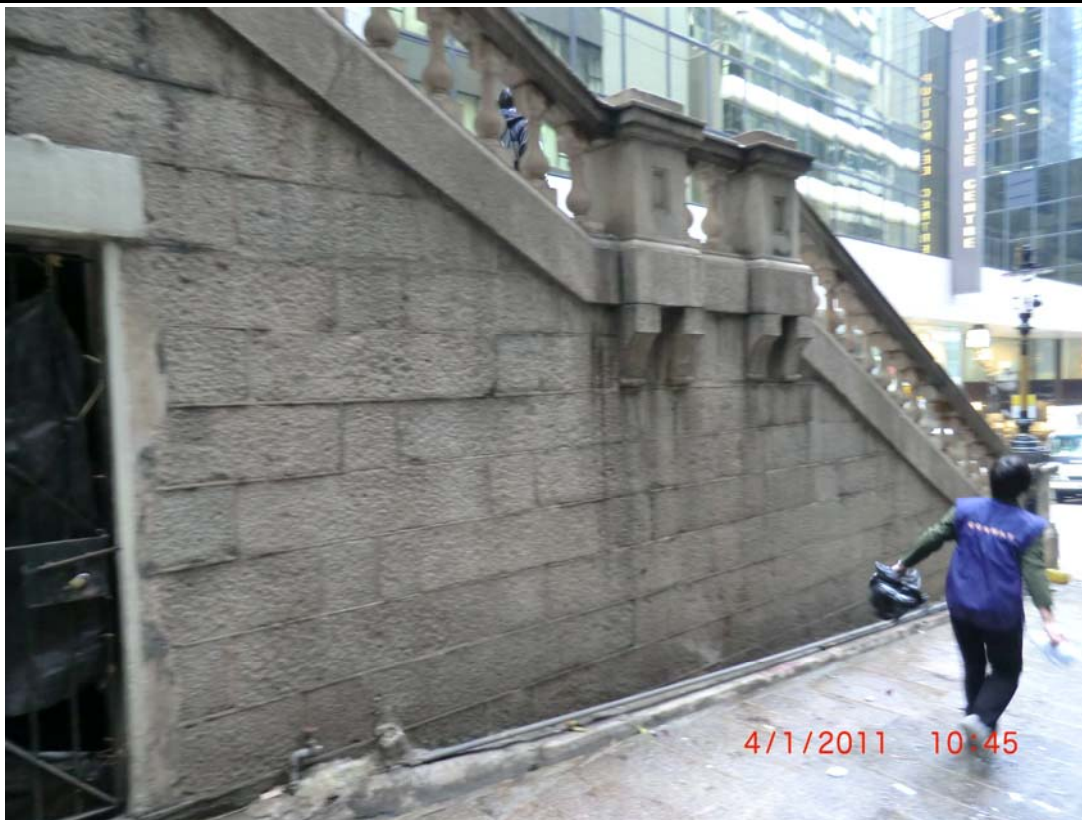
Subject Feature No. 11SW-B/R93 (Plate 8) **Date photograph taken** 04-Jan-11

Description General view showing part of the sidewalls of the declared monument

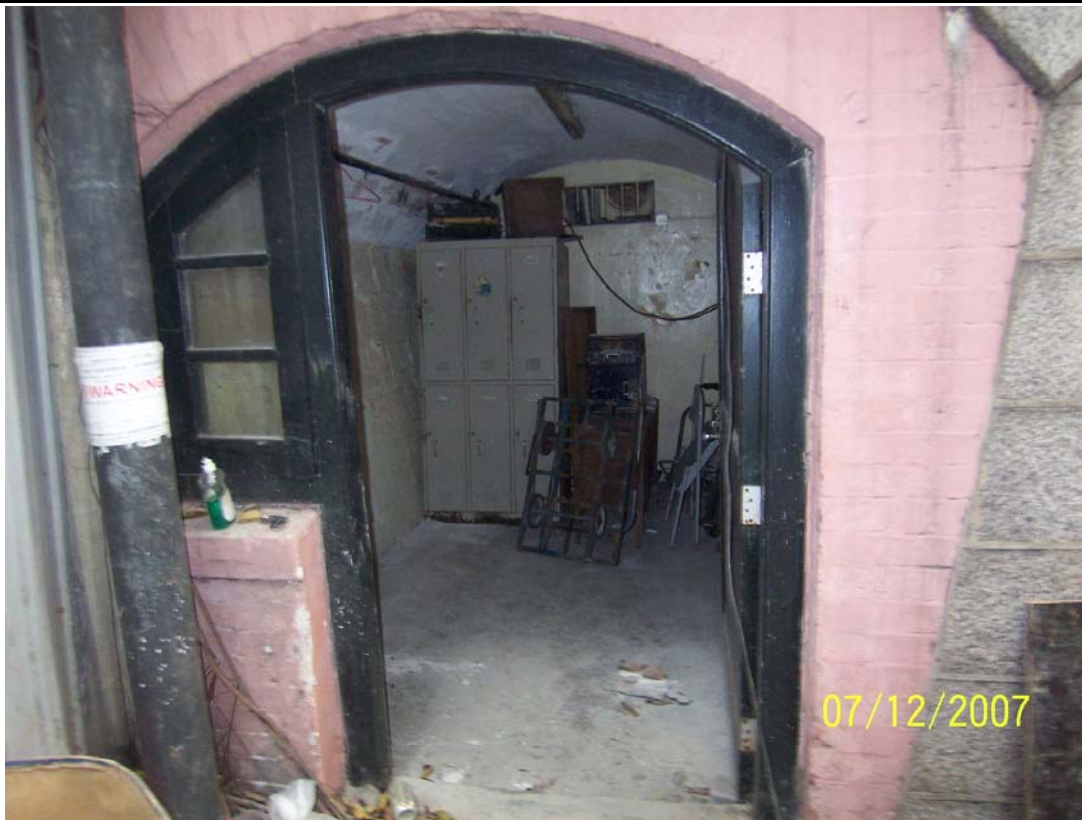
Subject	Feature No. 11SW-B/R93 (Plate 9)	Date photograph taken	07-Dec-07
----------------	----------------------------------	------------------------------	-----------

The interior of the storeroom with an arch lintel is painted yellow, rectangular in shape with a concrete floor of approximately 3.0m x 2.0m in size. The arch ceiling is in white colour with a fluorescent light installed in the middle. Some electric switch boxes are installed on the eastern wall behind the wooden door. During the inspection, none of the electricity apparatus are checked and their conditions are unknown. Except some ceiling plaster being peeled off near the western side, the storeroom is generally in good condition. During the inspection, some old furnitures such as steel cupboard, wooden chairs, bicycle and trolley are found inside the storeroom. Some traces of screw holes and core holes are left on the surface of the eastern and western walls inside the storeroom and on the concrete floor. It is believed that some previous core holes are carried out on these walls and floor during the ground investigation works. For the exterior, the storeroom is decorated by a pink granite arch with black wooden door and transparent glass windows at the southern side. The conditions of the door and glass are fair. A brick transom window with steel frame of size 0.35m (H) x 0.80m (W) is located 1.75m above ground at the northern side of the storeroom. The steel frame is corroded and in poor condition. The brick wall below the granite arch lintel is rigid with no cracks observed during the inspection (please refer to Plate 9 in Appendix B).

Description	General view showing the storeroom with a granite arch lintel above a wooden door		
--------------------	---	--	--

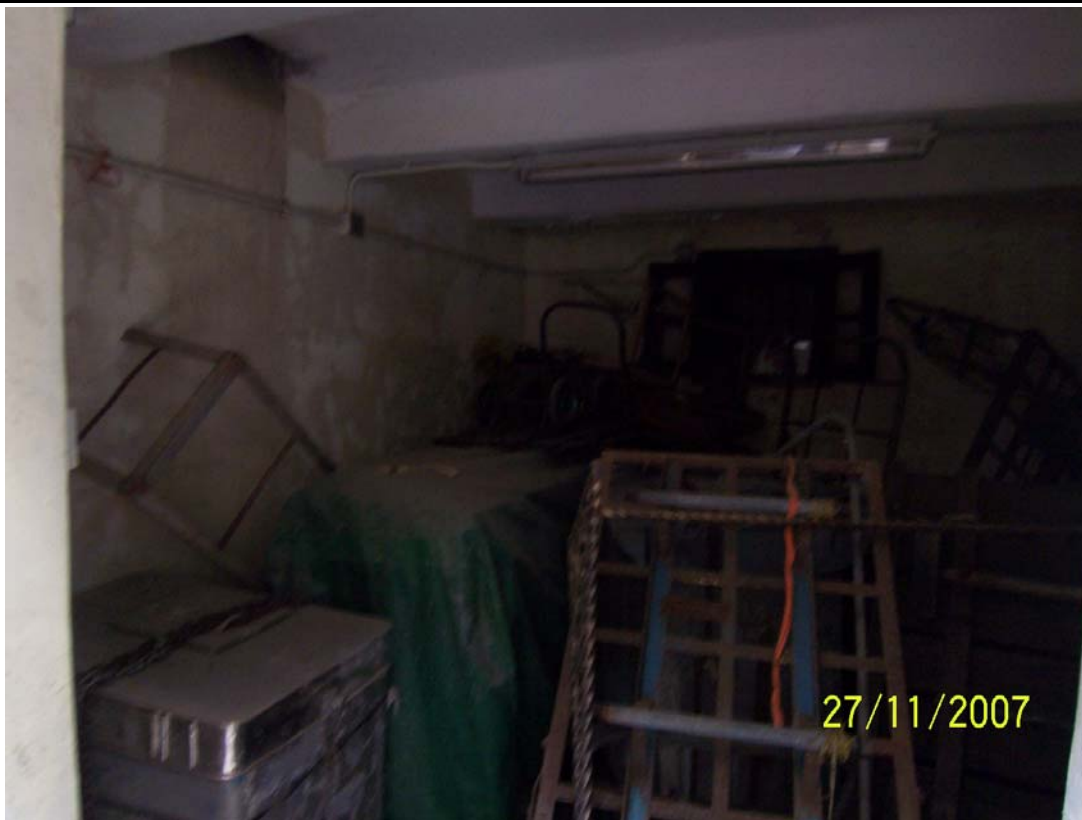
Subject	Feature No. 11SW-B/R93 (Plate 10)	Date photograph taken	27-Nov-07
----------------	-----------------------------------	------------------------------	-----------

shape as the first storeroom. Three beams are constructed in the ceiling and coloured in white with a florescent light installed in the middle. During the inspection, none of the electricity apparatus are checked and their conditions are unknown. The storeroom is fully stockpiled with miscellaneous items such as trolleys, cupboards and steel frames etc. Since the storeroom is fully occupied, the existing condition of the storeroom including the walls and the floor could not be inspected. A steel gate with a height of 2.15m and width of 1.07m is black in colour and in fair condition (please refers to Plate 10 in Appendix B).

Description	General view showing the storeroom with a rectangular steel gate		
--------------------	--	--	--

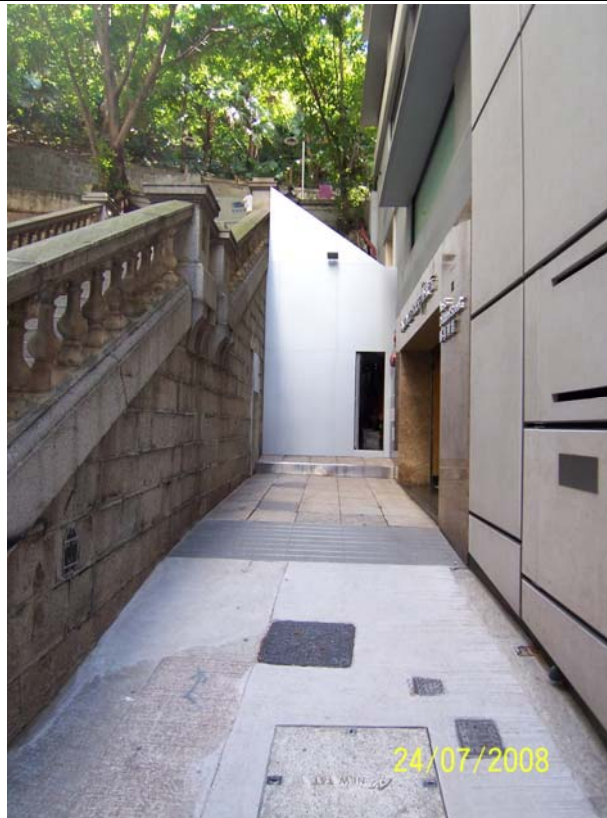
Subject Feature No. 11SW-B/R93 (Plate 11) **Date photograph taken** 24-Jul-08

For Portal 43 located at the northern side of the Feature, site inspection was carried out on 21 December 2007 during the ground investigation stage. The portal is constructed under a concrete counterfort enclosed by a brick wall and a grey colour steel gate of approximately 2.07m (H) x 1.00m (W). At the bottom right corner of the gate, an opening of approximately 0.36m (H) x 0.31m (W) is reserved for a 0.17m diameter PVC water pipe extended from the tunnels to a box channel. Behind the portal, the tunnel is rectangular in shape with masonry sidewalls and rows of flat precast reinforced concrete lintels at the ceiling. The tunnel is approximately 1.56m wide, 2.10m high and 9.85m deep (please refers to Plate 11 in Appendix B).

Description General view of the feature toe and Portal 43

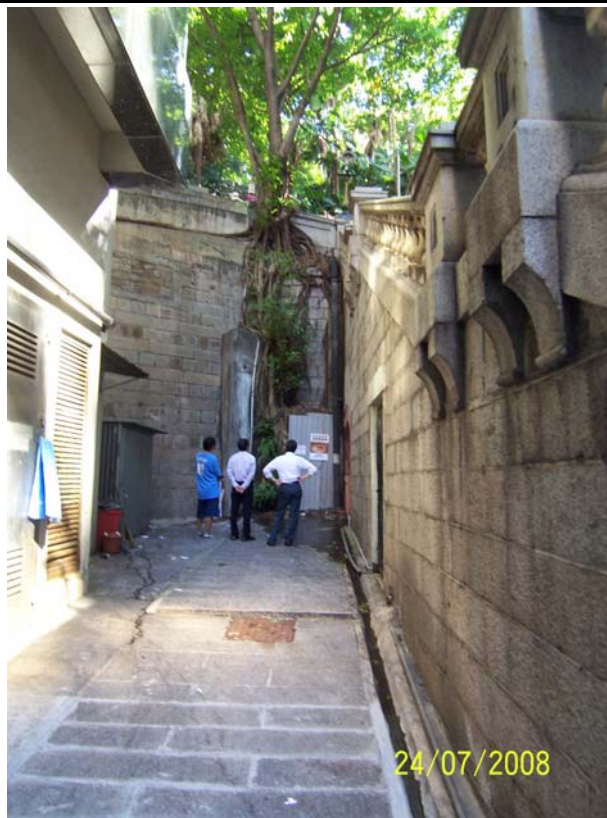
Subject Feature No. 11SW-B/R93 (Plate 12) **Date photograph taken** 12-Jan-11

Description General view of the feature toe and Portal 44

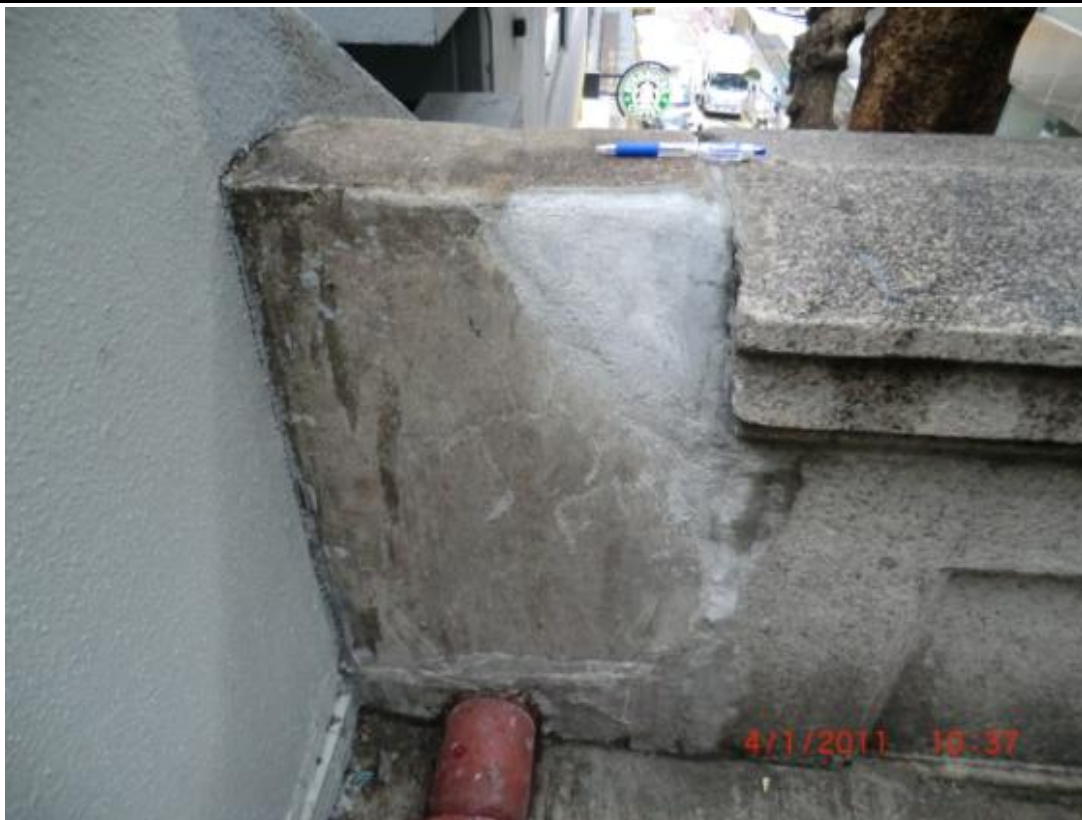
Subject Parapet wall at north-western side (Plate 2) **Date photograph taken** 04-Jan-11

Description View showing the reinstated portal of parapet wall at the north-western side of the feature

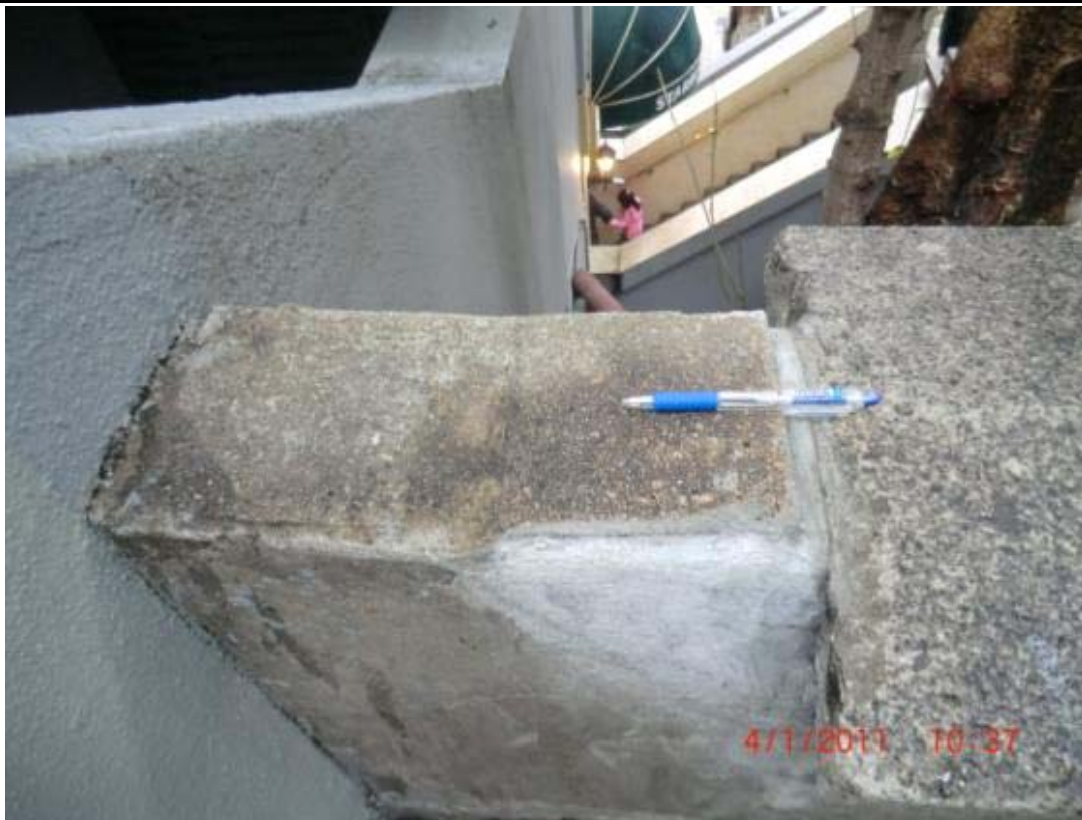
Subject Parapet wall at north-western side (Plate 3) **Date photograph taken** 04-Jan-11

Description View showing the reinstated portal of parapet wall at the north-western side of the feature

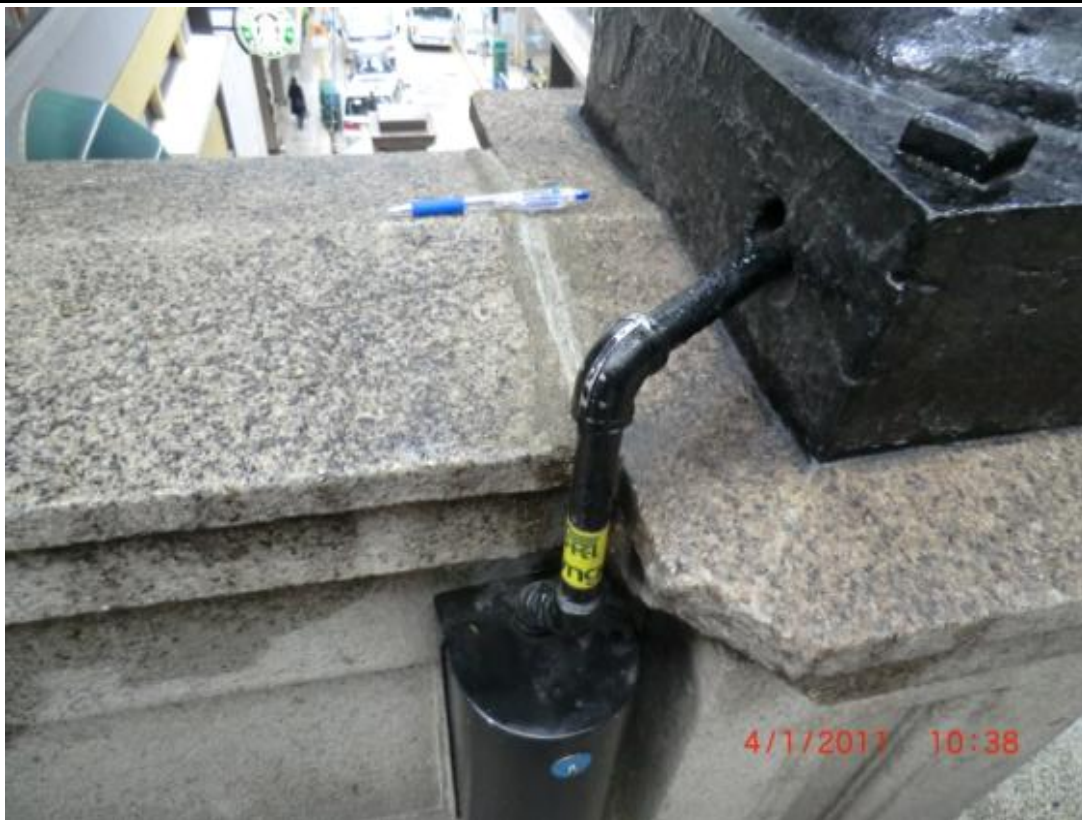
Subject Parapet wall at north-western side (Plate 4) **Date photograph taken** 04-Jan-11

Description Part of the corner at the box newel supporting the gas lamp is broken

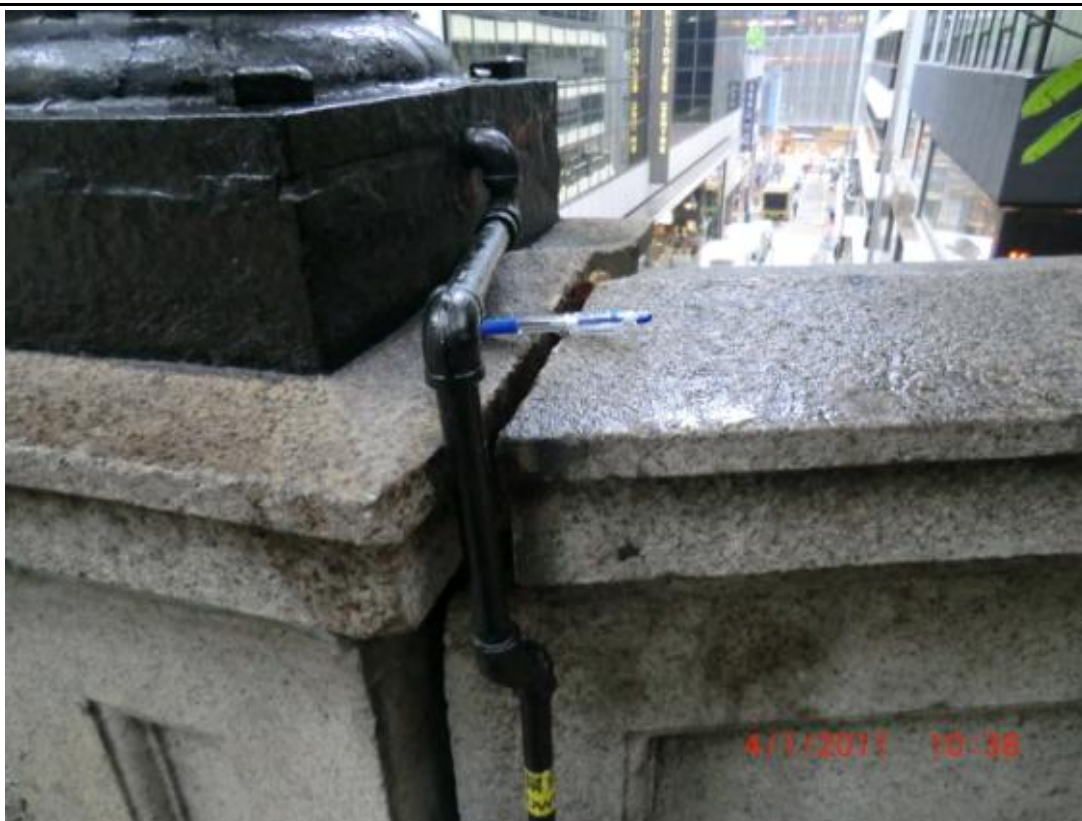
Subject	Parapet wall at south-western side (Plate 6)	Date photograph taken	04-Jan-11
----------------	--	------------------------------	-----------

Description	A gap between the box newel and the south-western side of the parapet wall is observed
--------------------	--

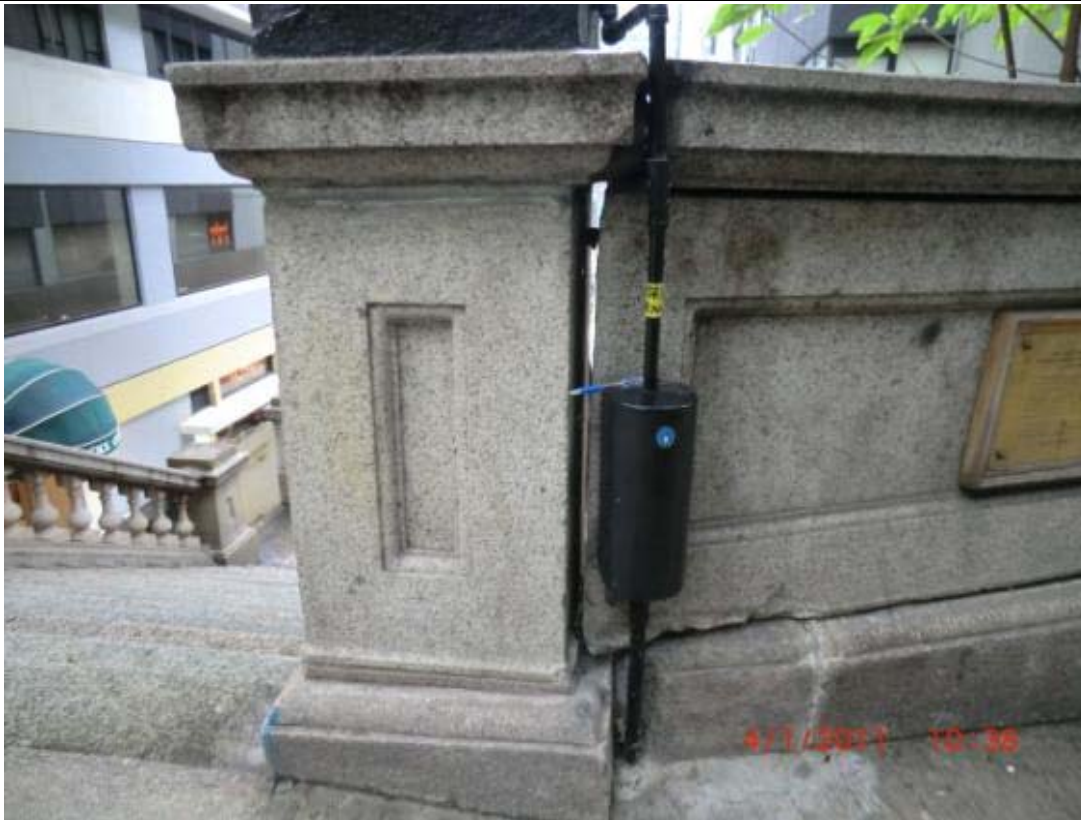
Subject Parapet wall at south-western side (Plate 7) **Date photograph taken** 04-Jan-11

Description A gap between the box newel and the south-western side of the parapet wall is observed

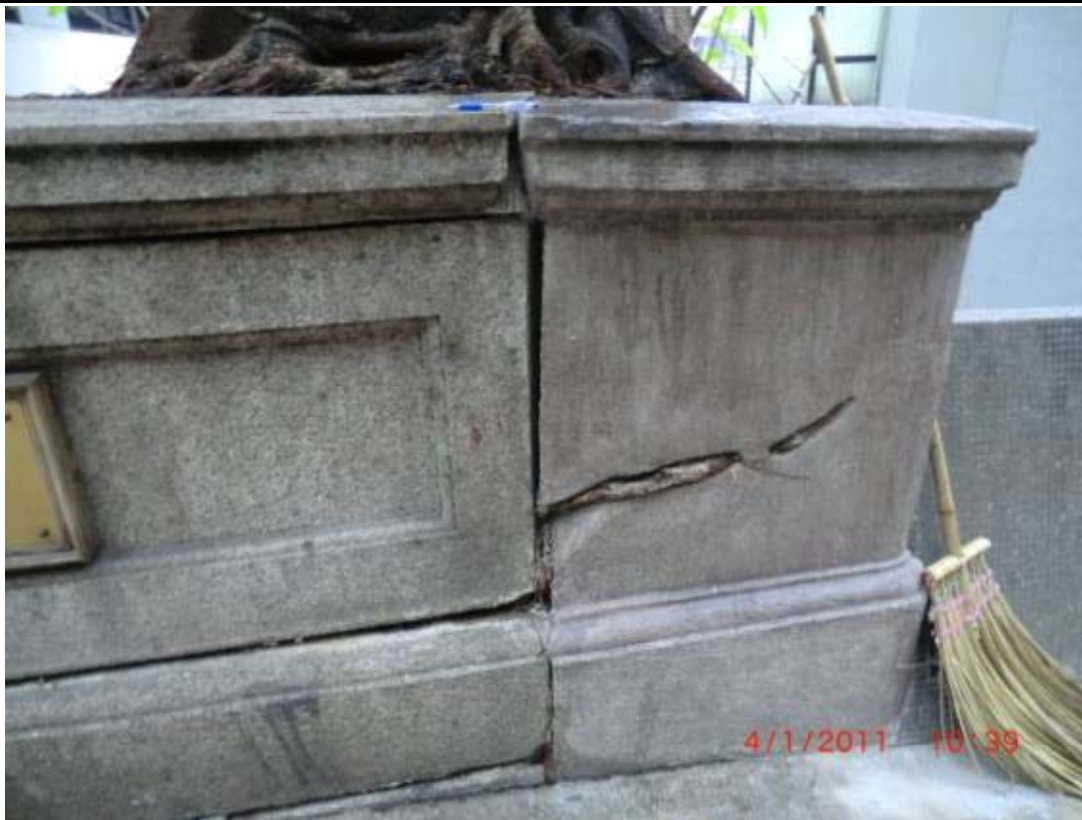
Subject Parapet wall at south-western side (Plate 9) **Date photograph taken** 04-Jan-11

Description One of the box newels at the south-western of the feature is damaged by the tree roots

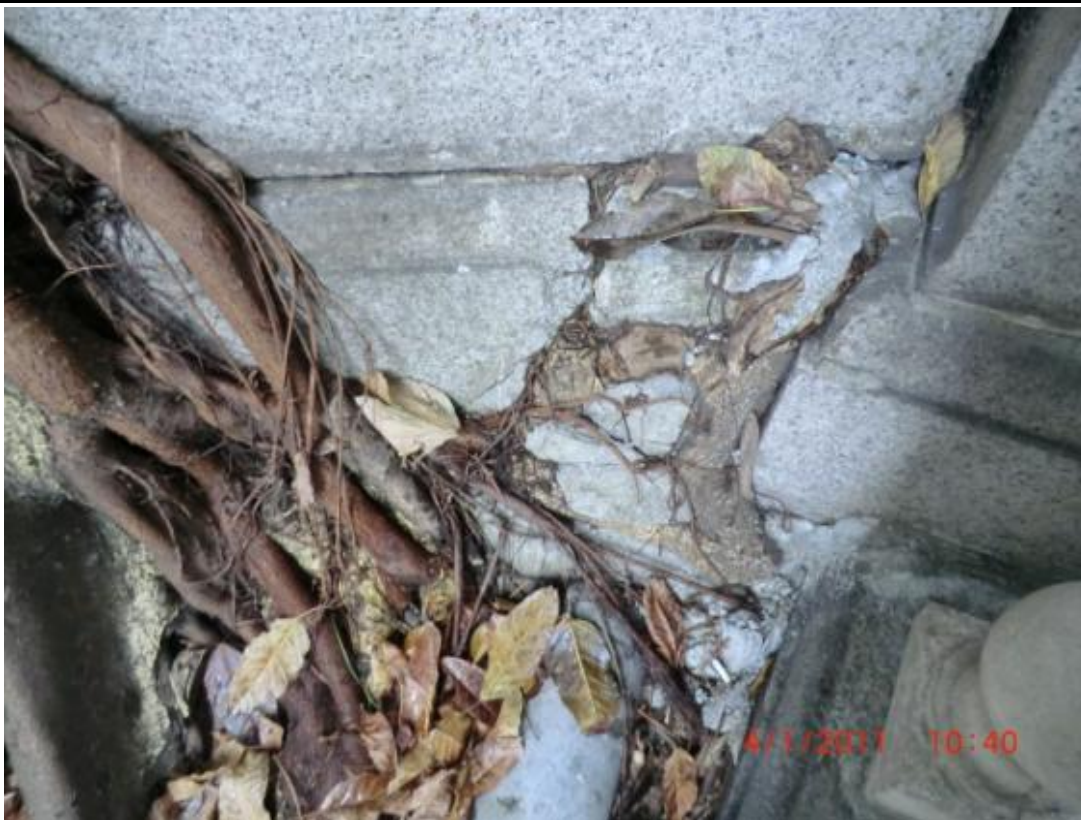
Subject Parapet wall at south-western side (Plate 12) **Date photograph taken** 04-Jan-11

Description Apparent cracks formed by the tree is observed at the south-western parapet wall

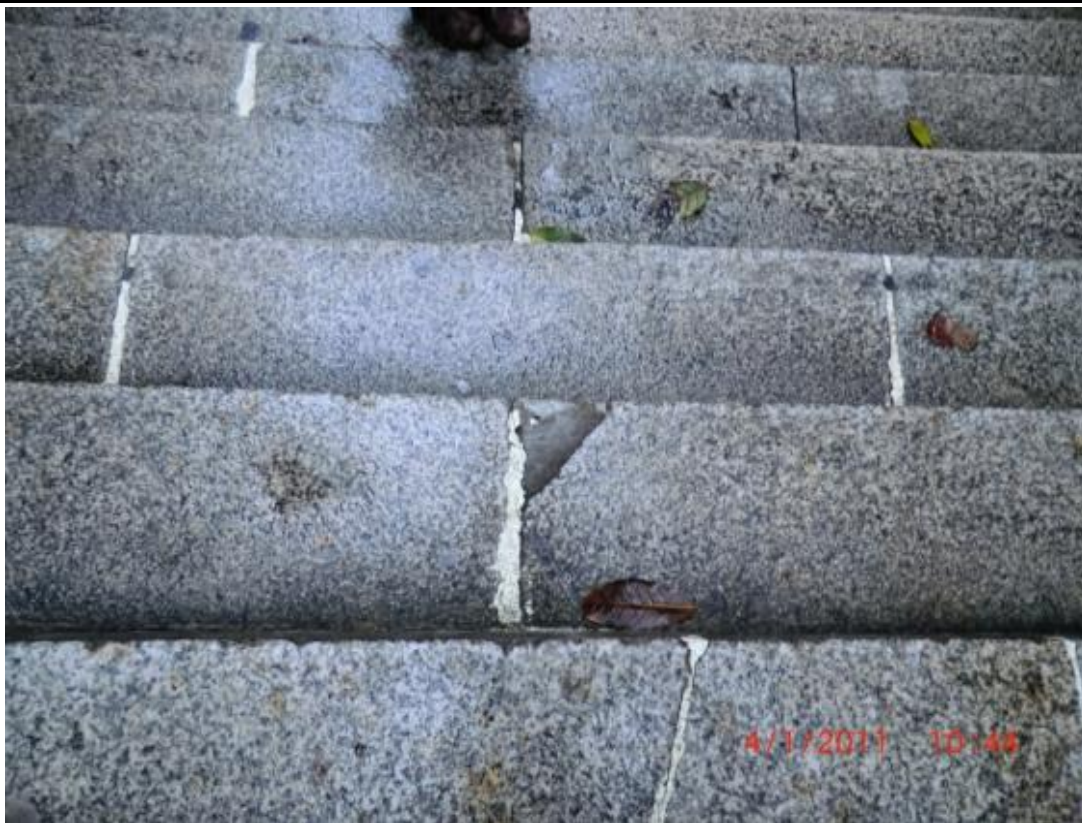
Subject	Granite Stone Staircase (Plate 14)	Date photograph taken	04-Jan-11
----------------	------------------------------------	------------------------------	-----------

Description	View showing the re-instatement works carried out for the granite stone staircase
--------------------	---
